What colour were the later Spanish 109s?

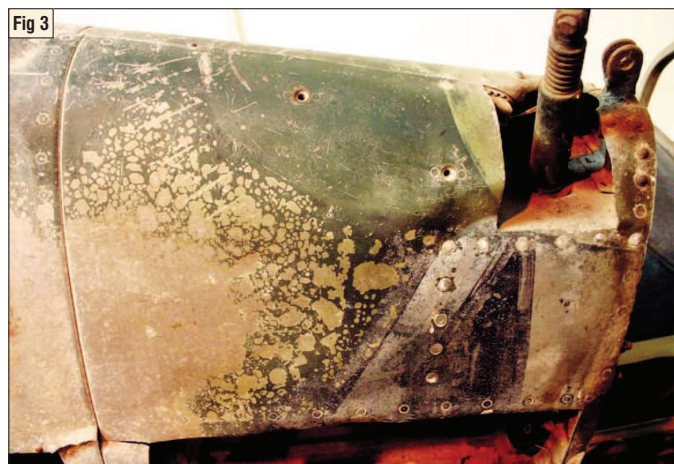
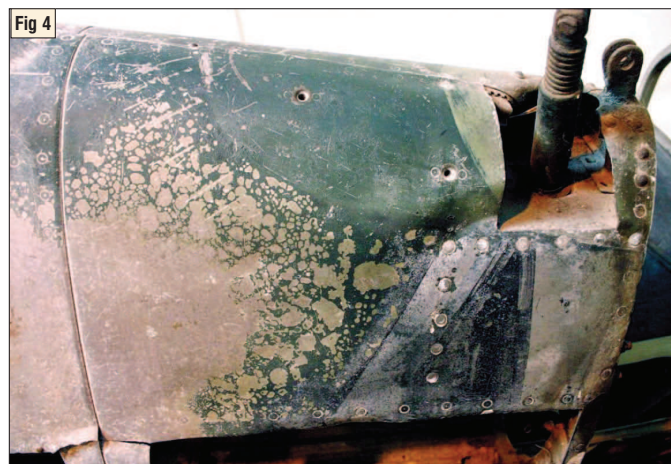
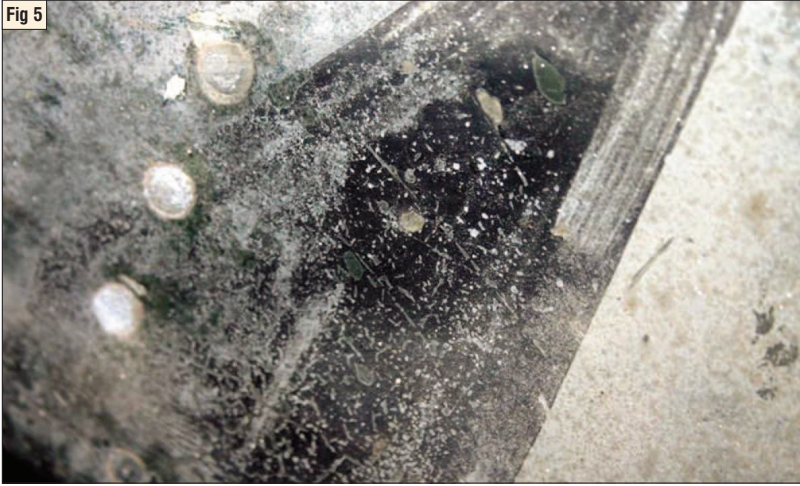
Figures 1 through 5 all show the top and side of fuselage stations 8 and 9, where the fin fairing bolted to the fuselage itself. The first thing which is immediately evident is that the aircraft was originally finished in 70 and 71, as shown by the close-ups in figures 1 and 2. Figure 3 is a photo taken in ambient light with no flash; there has been no color correction applied in this photo. Figure 4, however, is the same shot with the orange-yellow tinge removed via Adobe Photoshop. While still not perfect, this gives a more realistic interpretation of the colors on the airframe. Figure 5 is a view of the port side of fuselage section 9, while figure 6 shows the starboard side of section 9, at the point where the rudder meets the fuselage. The cold, light grey tones in these photos are remnants of the oxidized surface paint; note the chipped areas where the underlying coat of 70 and 71 shows through. In Figure 6, several fresh scrapes in this paint show a slightly warmer tone, more consistent with a faded 63 Hellgrau, which was quite similar to RLM 02 in tone and hue. These photos, while not 100% conclusive, do give strong credence to the theory that 63 was used on the upper surfaces of Messerschmitts in Spanish service.

An interesting opportunity to test this theory has recently presented itself. In mid-2005, a Bf 109E-3 hulk was offered for sale by William Moore of AeroLocker (www.aerolocker.com). As it turns out, this aircraft was the second Emil to be sent to Spain, where it received the code 6 o 88. The aircraft spent its entire service career in the Spanish Air Force, being unceremoniously consigned to a dump at the end of its service life. Fortunately, the remains were recovered, and will form an excellent basis for a thorough restoration (back to its original Spanish identity, it is hoped!). Mr. Moore was contacted regarding this aircraft, and he was gracious enough to supply several photographs of the tail area, which still retains a good
