To See Was to Live

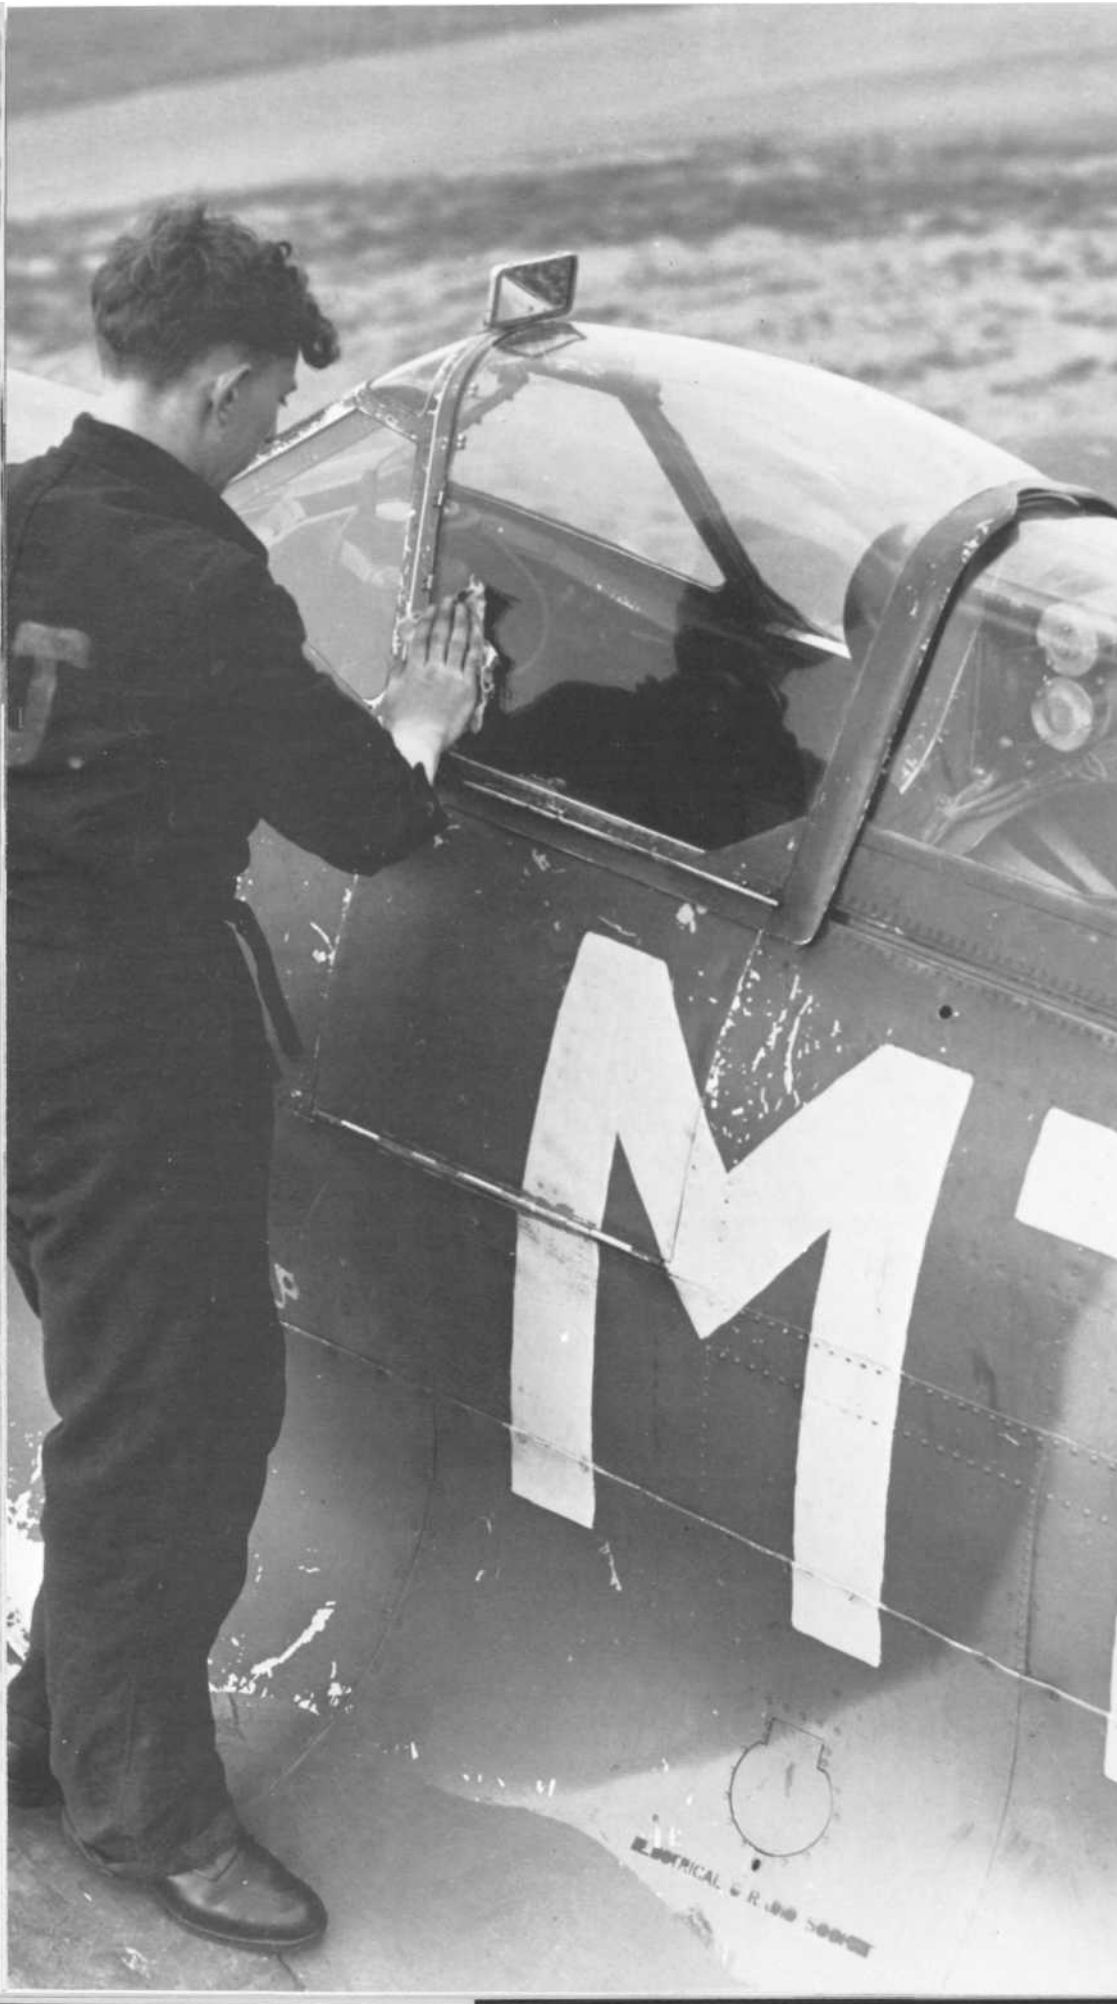
Left: With so much at stake, the cleaning of the canopy assumed an almost ritualistic importance prior to an operational sortie. A fragile material, perspex could be scratched unwittingly even by wiping it with a handkerchief; only the very softest of cloths could be used for cleaning it.

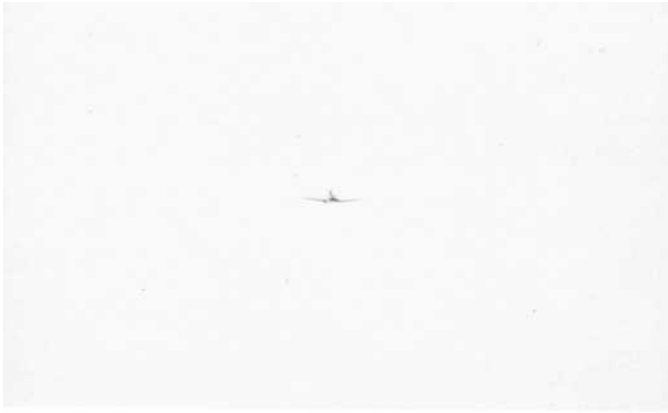
Although the side perspex might appear transparent when looking at objects down sun, Top right, a glance at the same objects into sun soon revealed the extent of light-scattering due to even the slightest scratching on the hood.

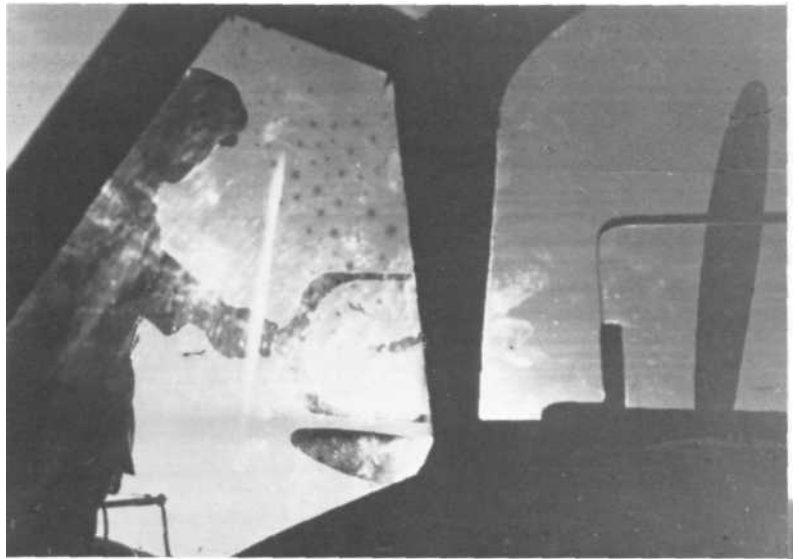
A problem, and a solution. Oil slinging was a common occurrence from the constant-speed propellers fitted to

Spitfires. In the photograph (Below) taken immediately after a fight, the left half of the windscreen had been cleaned while the right half had had the oil left on; note the deterioration in visibility caused by the oil. Some Spitfires, like this one (Below right) were fitted with a simple locally-made oil collector ring to prevent the oil from spraying on the windscreen.
