## MEMORANDUM REPORT

Army Air Forces, Materiel Command

MEASUREMENTS OF THE FLYING QUALITIES OF

A BELL P-39D-1 AIRPLANE (A.A.F. No. 41-28378)

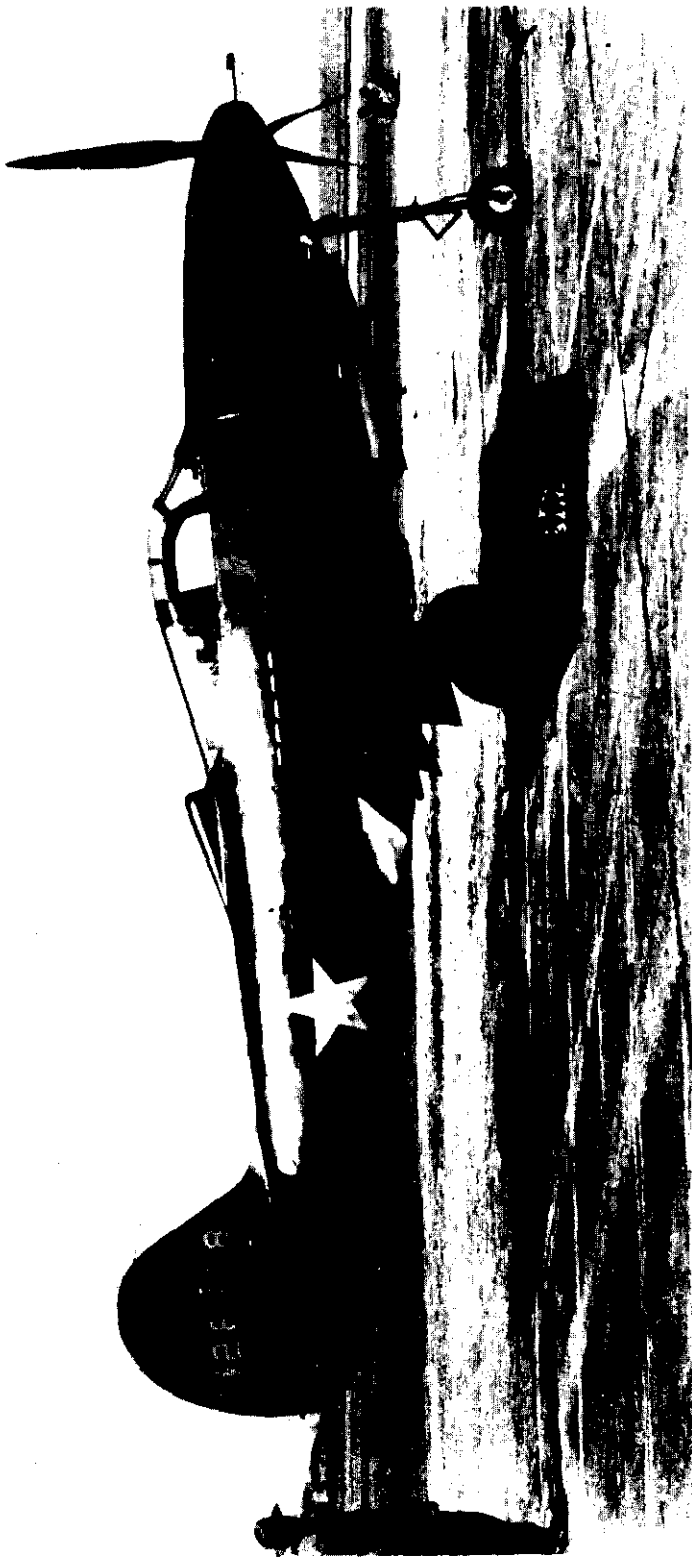
Figure 2.- Side view of the Bell P-39D-1 airplane.

The Bell P-39D-1 airplane is a single-place, single-engine, full-cantilever, low-wing, pursuit-type airplane having partial-span, split-trailing-edge type landing flaps and a retractable tricycle-type landing gear. Construction is of metal except for the fabric covering on control surfaces. Power is supplied by an Allison V-1710-35 engine mounted below and behind the pilot's compartment and is transmitted to the propeller by an extension shaft running to a reduction gear box in the nose of the airplane. Armament consists of two 30-caliber guns in each outer wing panel, two 50-caliber guns on the cowl, and a 20-millimeter cannon firing through the propeller hub. Photographs showing general views of the airplane are reproduced in figures 1, 2, and 3, respectively. A three-view drawing

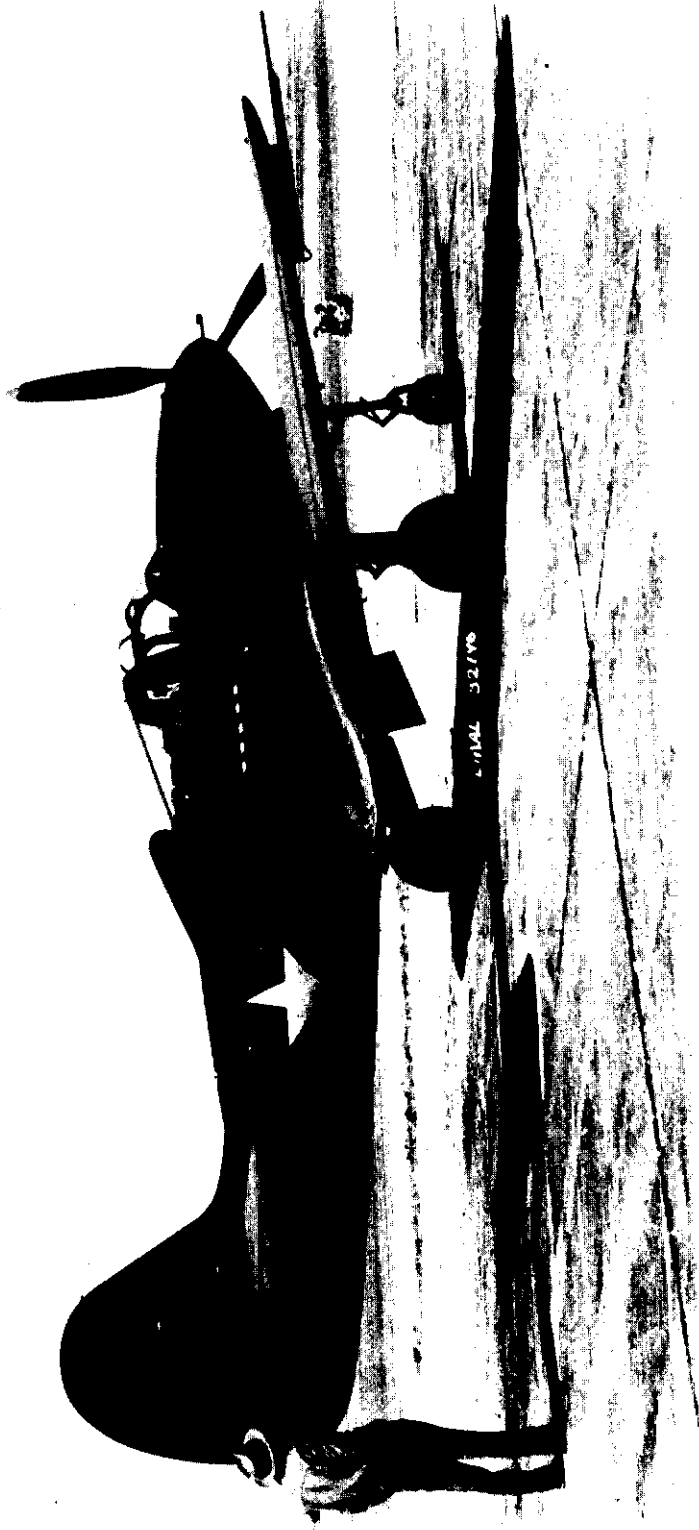
Figure 3.- Three-quarter rear view of the Bell P-39D-1 airplane.

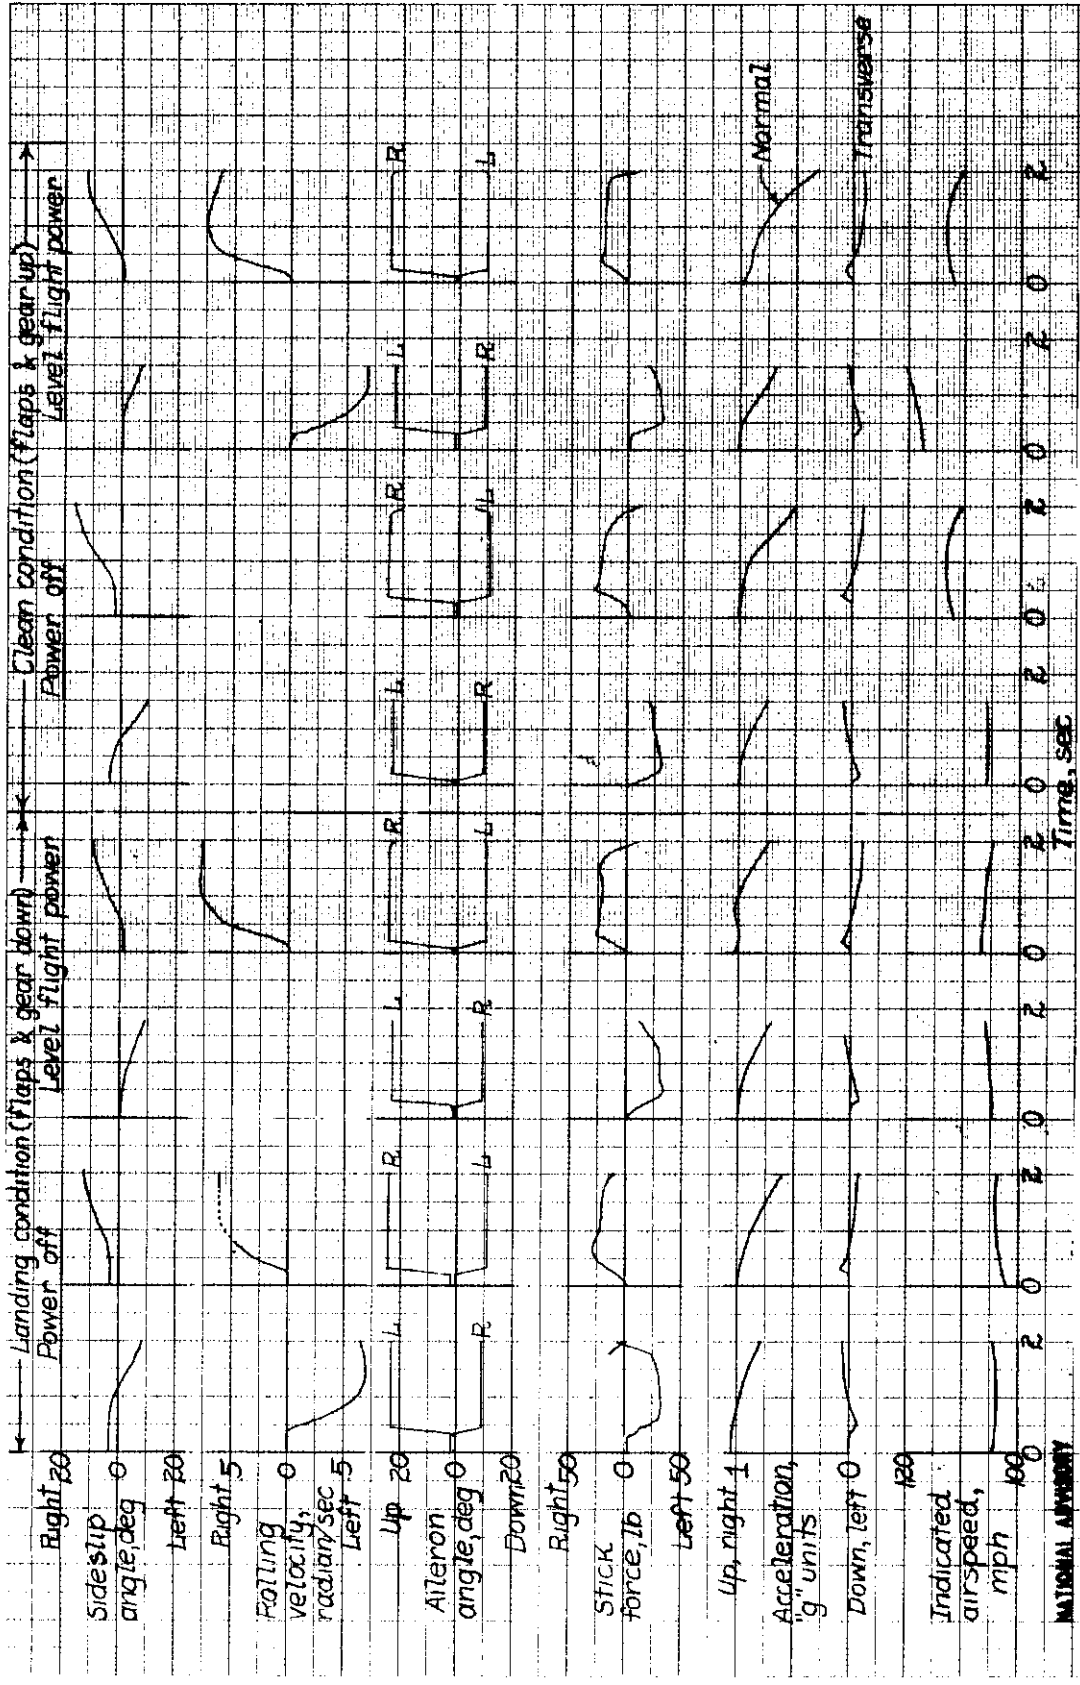
Figure 24. - Time histories of full-deflection aileron rolls made with rudder held in trim position showing adverse aileron yaw at low speeds. Bell P-39D-1 airplane. Note: Stick force includes force against aileron stop at full deflection.

The yawing moment due to sideslip with rudder fixed was investigated by making full-deflection aileron rolls while holding the rudder in its trim position and noting the maximum angles of adverse yaw resulting from rolling. Both the clean and the landing conditions of flight were investigated with power off and power for level flight at speeds about 20 percent greater than the respective power-off stalling speeds. Data from these maneuvers are shown as time histories in figure 24. Significant results are:

The rolling moment due to sideslip resulting from abrupt aileron deflections, rudder fixed, was never so great that a reversal in rolling velocity occurred. This is in accord with the requirements. Data illustrating the effect on rolling velocity of the yaw due to ailerons for critical low-speed flight conditions may be found on figure 24.
